RICHELIEU RIVER BASIN
HARDWICK, VERMONT

HARDWICK LAKE DAM VT 00186

PHASE I INSPECTION REPORT NATIONAL DAM INSPECTION PROGRAM

OCT., 1980

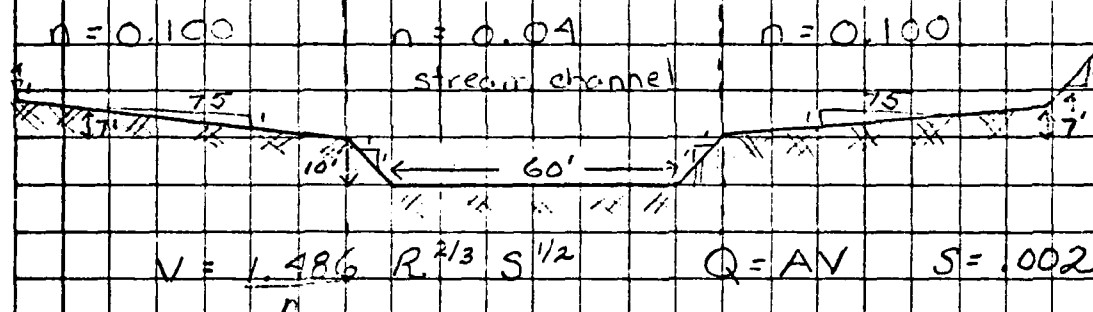
Typical Cross-section 100 - 3450 ft D/S of the Dam

Reach A

H	A	P	R	V	Q
2	124	65.6	1.87	2.54	315
4	256	71.31	3.59	3.90	997
6	396	76.97	5.14	4.95	1961
8	544	82.63	6.58	5.84	3175
10	700	88.28	7.93	6.61	4624
12	860	88.28	9.74	7.58	6517
14	1020	88.28	11.55	8.49	8661
16	1184	88.28	13.37	9.36	11041
17	1260	88.28	14.27	9.78	12317

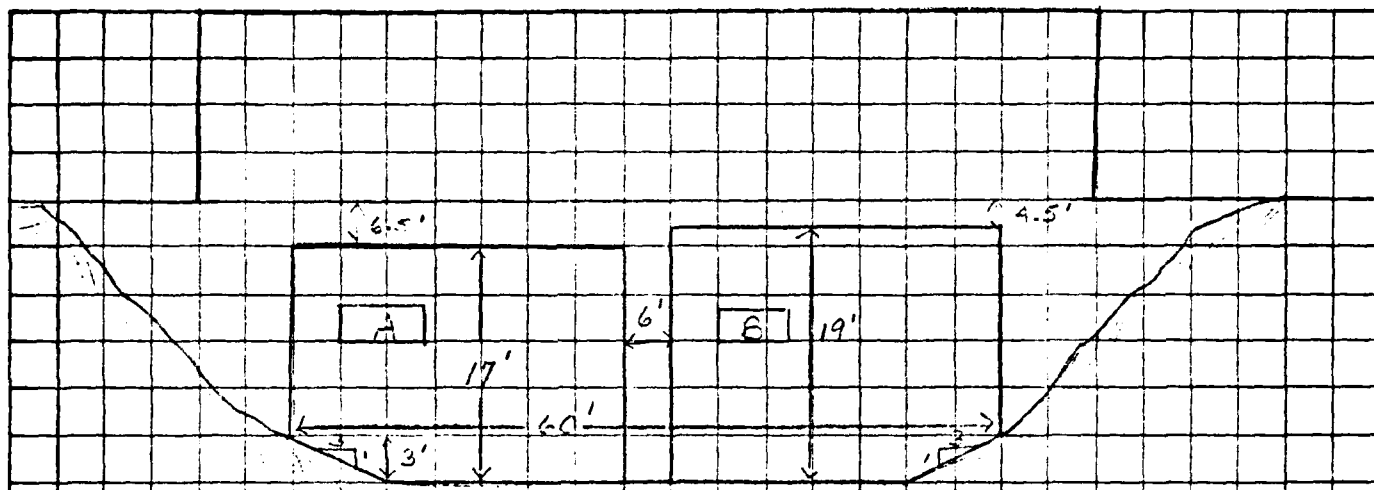
b) Covered Railroad Bridge

Critical Section approx. 15000 feet D/s
